Subject: **Field Tests of Orage Corporation Hurricane Harness Tie-Down System**

*Introduction:*

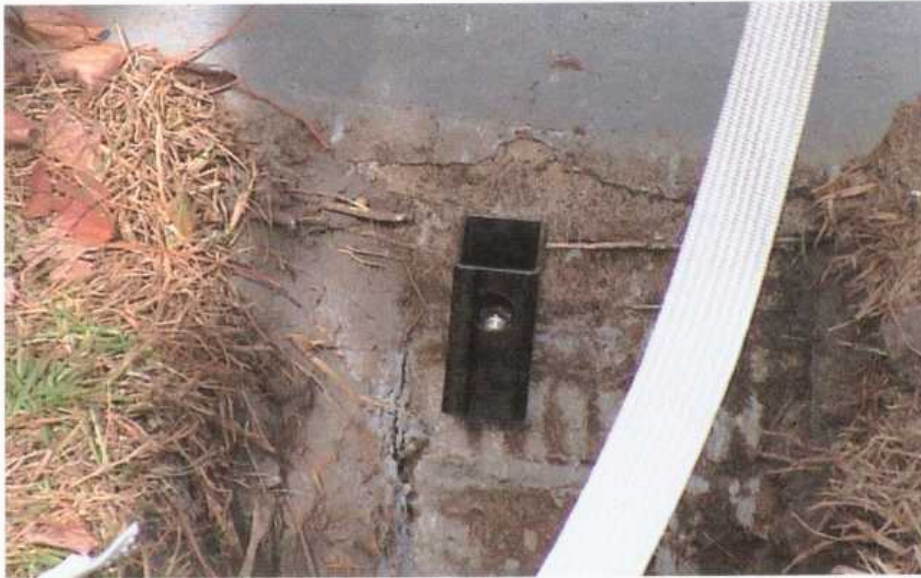
Figure 1. Anchor Bracket Attached to Foundation Using Epoxy Grouted Stainless Steel Anchor Bolt.

The Orage Corporation's over-the-roof strapping system referred to as the "Hurricane Harness Tie-Down System," was installed as one of the retrofits evaluated during field tests that were conducted in November 2001. This system employs stainless steel anchors installed in the foundation wall or footing and a strapping system with a ratchet type tightening device to pull the straps tight. The steel bracket attached to the stainless-steel anchor is shown in Figure 1. In this demonstration test, the anchors were positioned four feet apart, on opposite sides of the house, along the exterior walls of the house below the eaves. A strap is placed over the roof between the two opposite anchor points and a ratchet device is used to tighten the strap so that it tends to anchor the roof to the foundation. Figure 2 shows the two Orage Straps installed at 3656 Eagle Trace in Horry County, South Carolina. This photograph was taken at a point in time when the straps had not been straightened out and tightened. An Orage Corporation employee performed the installation. The only deviation from a typical installation, that we are aware of, was that we connected a load cell between one of the anchors and its associated strap in order to monitor the load in the strap.

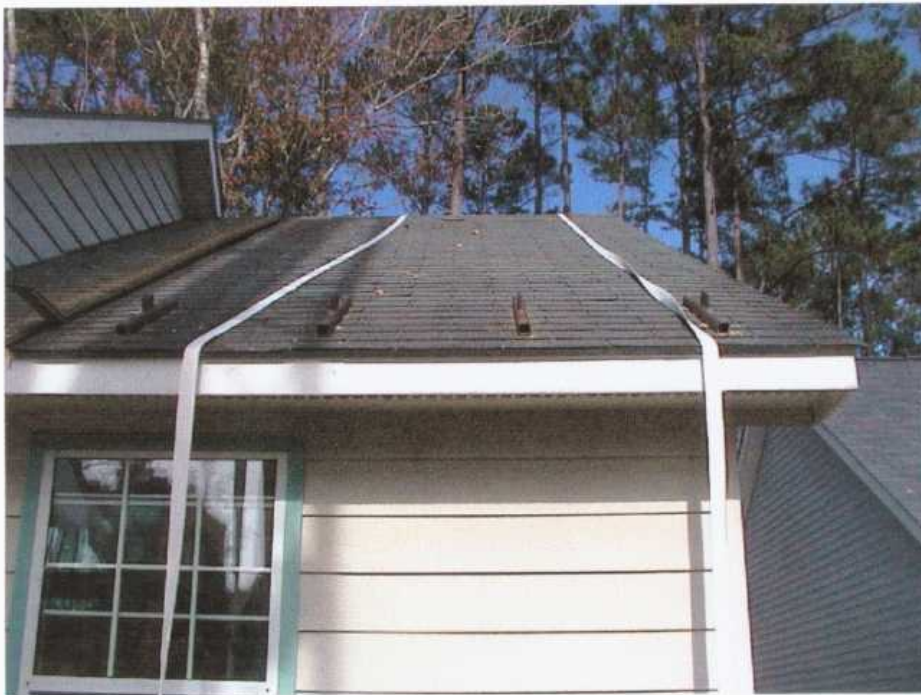
Figure 2. Orage Corporation Over the Roof Straps on 3656 Eagle Trace.

isolated from the rest of the building by cutting through the roof sheathing and ceiling sheetrock to the left of the farthest left loading bracket. The cut in the roof sheathing is visible in Figures 2 and 3. A loading tree was used to apply uplift loads to each truss in the roof segment to be tested as shown in Figure 4. In addition to the load cell used to monitor the load in the strap, load cells were also connected between the loading tree and each of the loading brackets (Figure 4). A final load cell was connected between the top of the loading tree and the crane hook (also see Figure 4). This load cell provided an overall measurement of the total load applied to the segment of the roof being tested. The six load cells were monitored simultaneously by a PC based data acquisition system for the duration of the test. The load cells were obtained from Omega Engineering and each had its own calibration certificate traceable to NIST. The load cells were bought within 6-months of this series of tests, so their calibrations were within 6-months of the tests. The load cells were connected to Vishay strain gage conditioning amplifiers with gains set at 200 and excitation voltages set at 10 volts. The outputs of the Vishay strain gage amplifiers were connected directly to the Computer based data acquisition system.

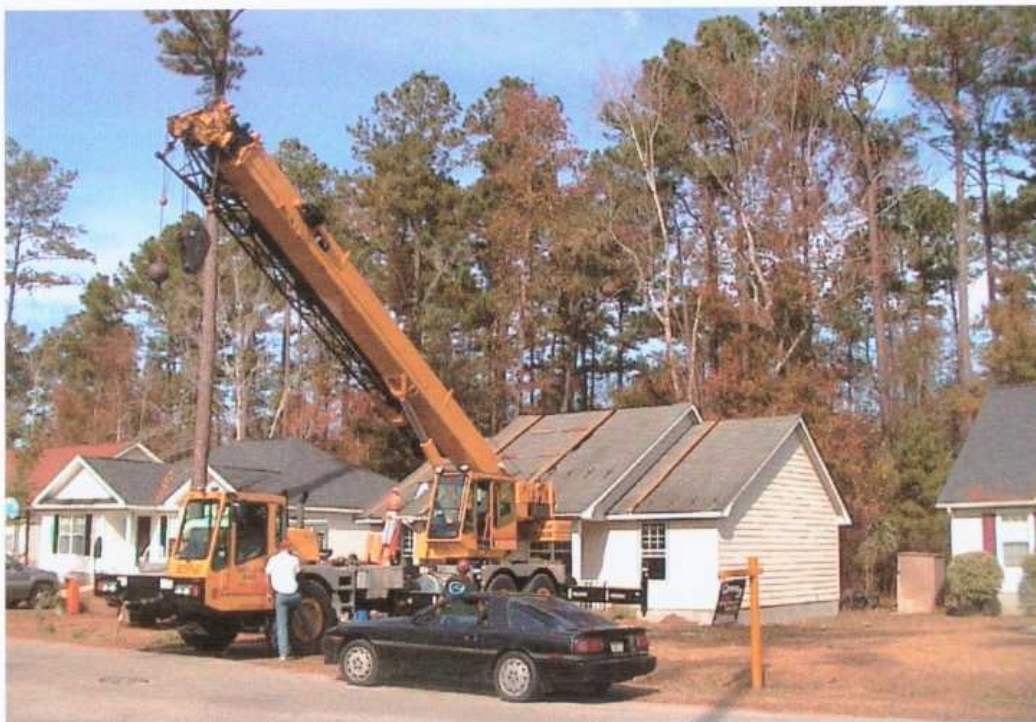
Figure 3. Crane Used to Conduct Uplift Tests with 3656 Eagle Trace in Background.

Vertical uplift loads on the roof structure were applied using the 40 Ton Crane shown in Figure 3. The portion of the house used for the Orage Corporation retrofit test is the right hand end of the house as shown in Figure 3. The portion of the roof structure engaged in the uplift tests was

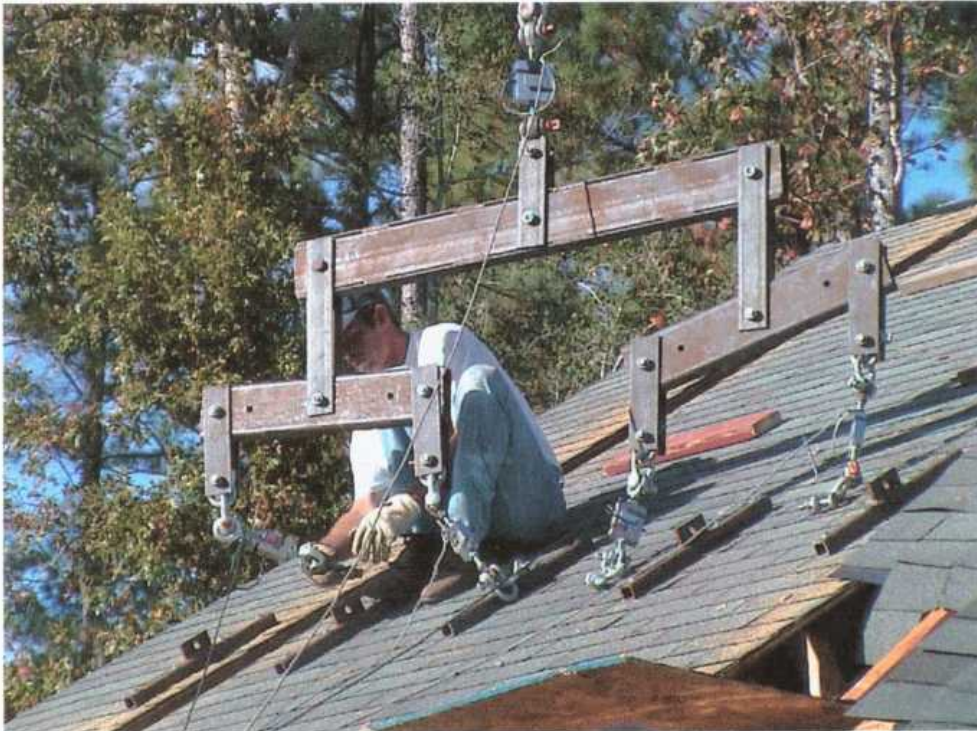
Figure 4. Loading Tree and Load Cells Used in Uplift Tests

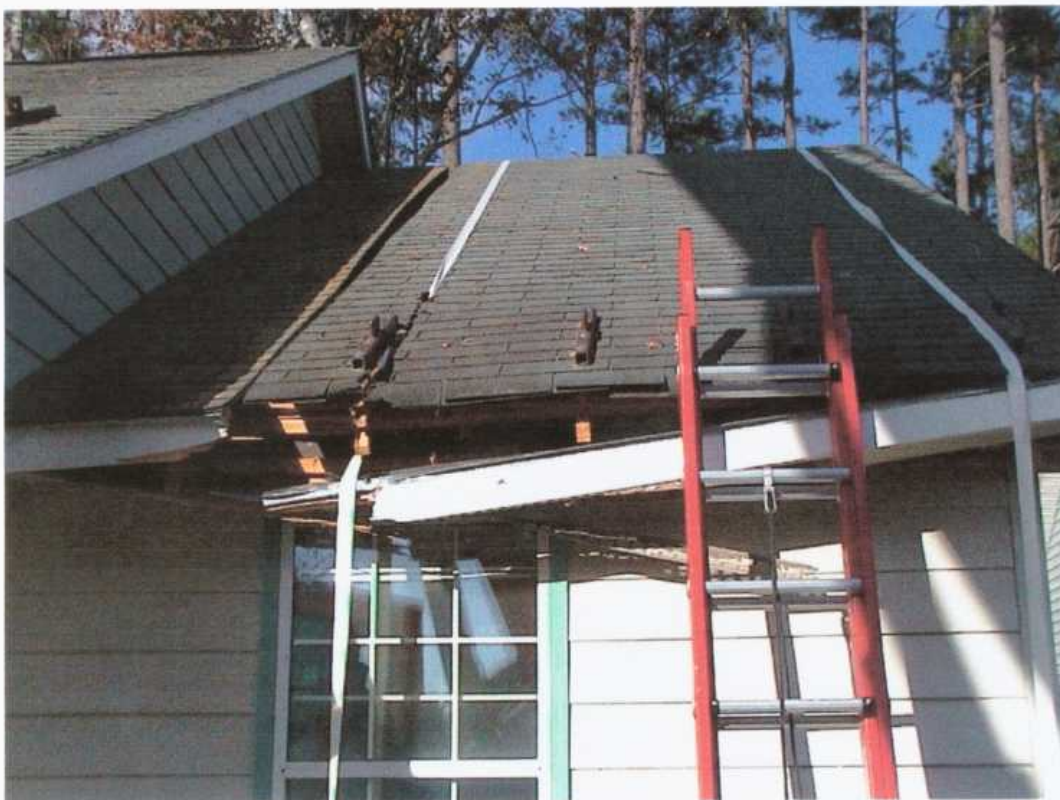
Figure 5. Roof of 3656 Eagle Trace with Orage Corporation Straps After Testing.

rafters. As such, these fascia boards may not provide a significant amount of resistance to the large vertical component of the loads applied by the straps. The left hand strap clearly cut through the roof sheathing (see Figure 5).
